A Brief History of Connecticut's Crumbling Foundations

By Kevin E Miller

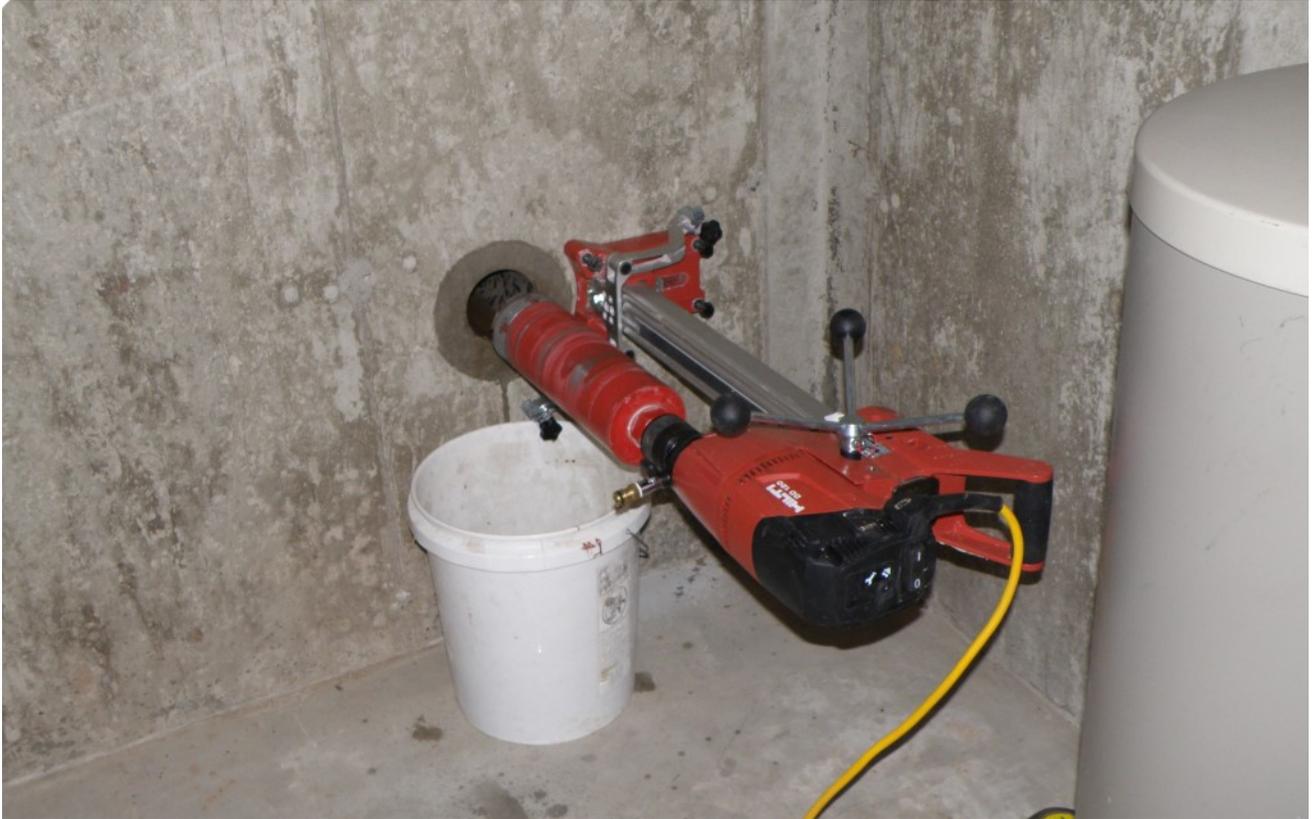
Coring a Foundation Wall to Test for the Presence of Pyrrhotite in the Concrete
